SUBJECT: CAFO Inspection,
FOIA Ex. 6
(Personal) Farms, Henry County, Ohio

Concentrated Animal Feeding Operation Inspection Report

Farms, Dairy and Satellite Facilities
New Bavaria, Ohio

Inspected August 16 and 17, 2016

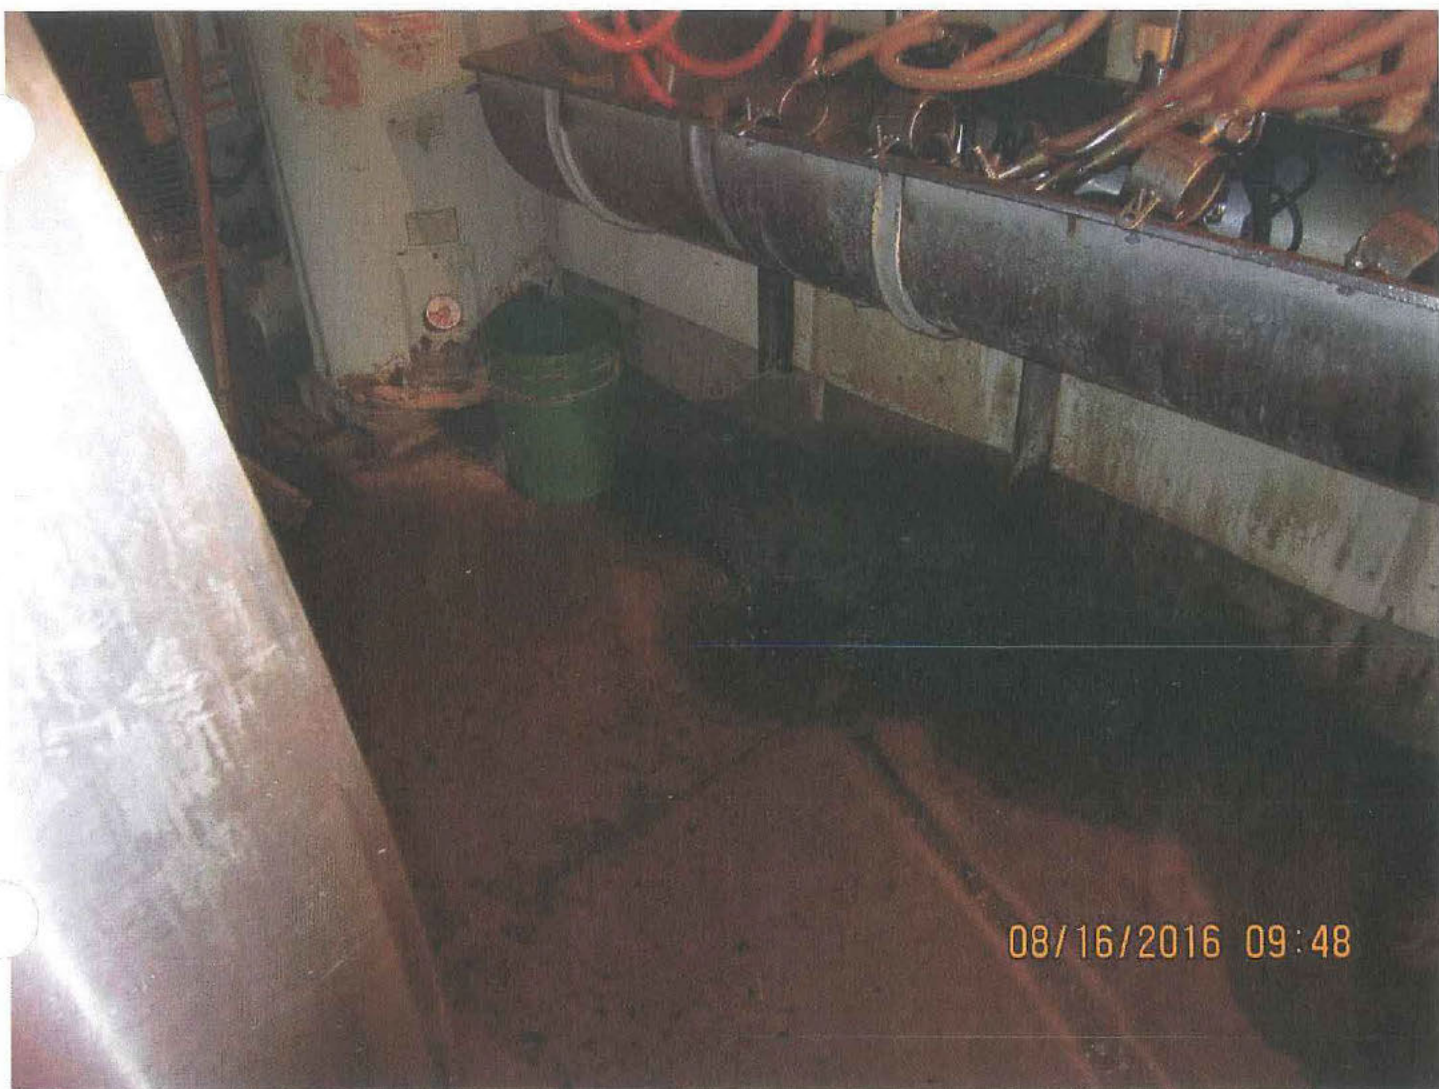
Photograph No. 1 (file IMG_0711)

Description: Floor drain along the east wall of the Milk Tank Room. There are three floor drains in this room.

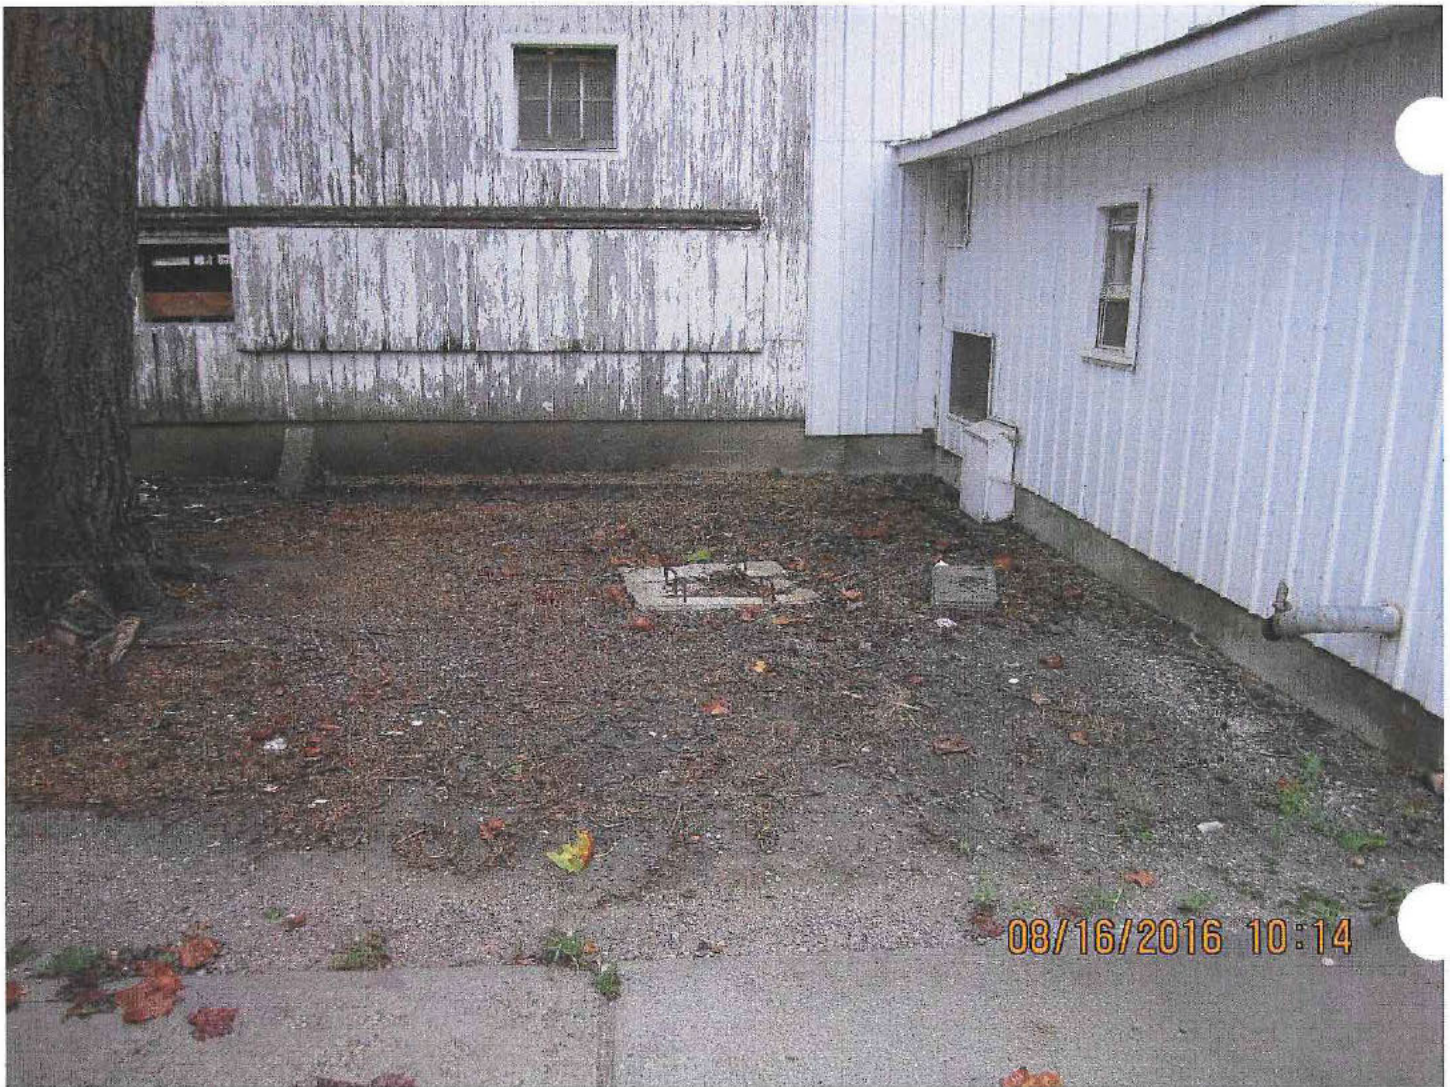
Photograph No. 2 (file IMG_0722)

Description: An exterior catch basin on the north side of the Milk Tank Room receives the floor drain drainage from the Milk Tank Room. Milk tanks are rinsed with well water and that rinse water is drained onto the floor of the Milk Tank Room to drain through the floor drains into this catch basin. This catch basin is plumbed via underground piping to discharge into the steel reception basin at the end of the drainage trench.

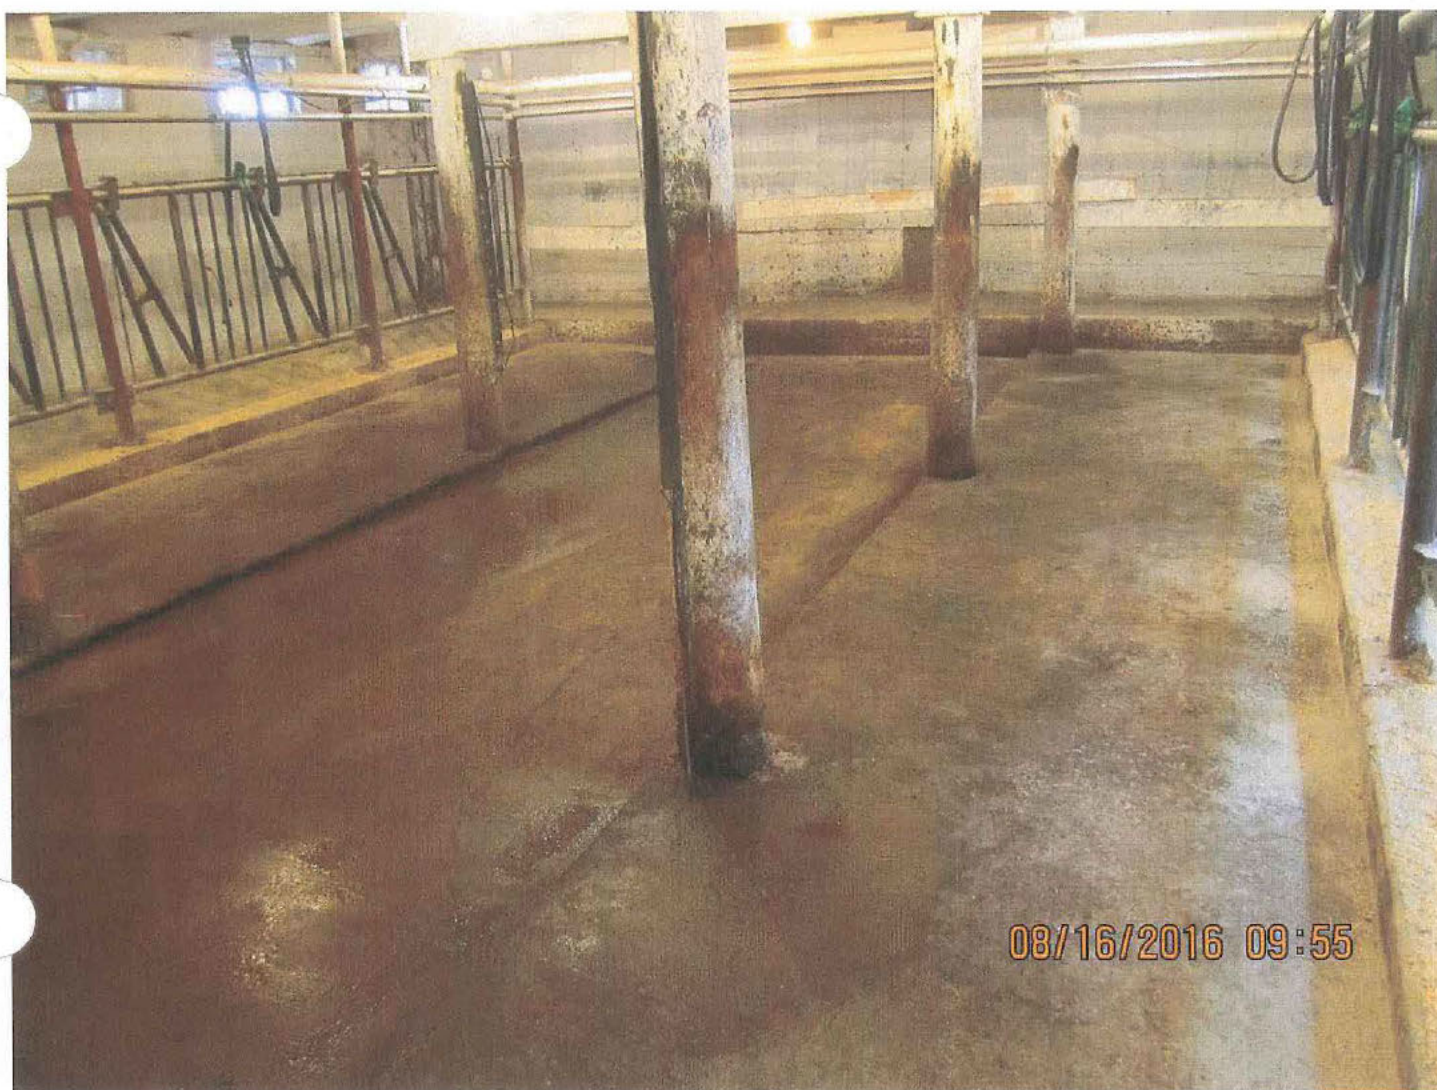
Photograph No. 3 (file IMG_0712)

Description: There are no floor drains in the Milking Parlor. A skid steer is used to scrape manure from the floor and this manure is then dumped into the concrete Manure Storage Vault.

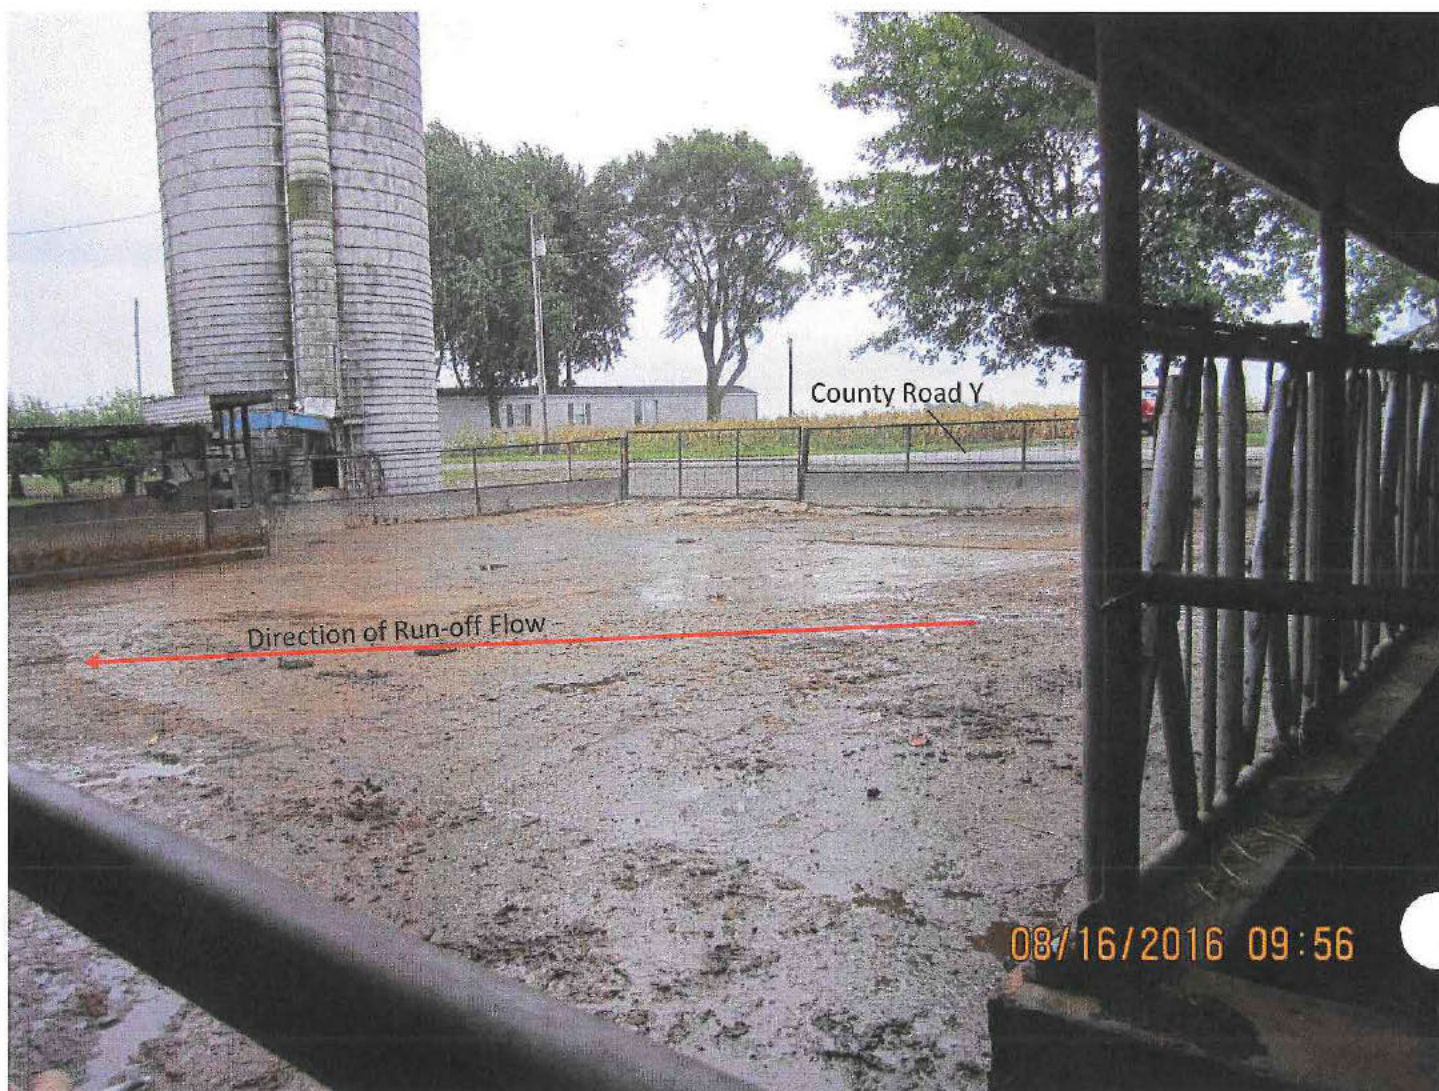
Photograph No. 4 (file IMG_0713)

Description: View of the concrete corral area on the east side of the Milking Parlor. Storm water run-off flows from this area to the north/northeast to the constructed drainage trench.

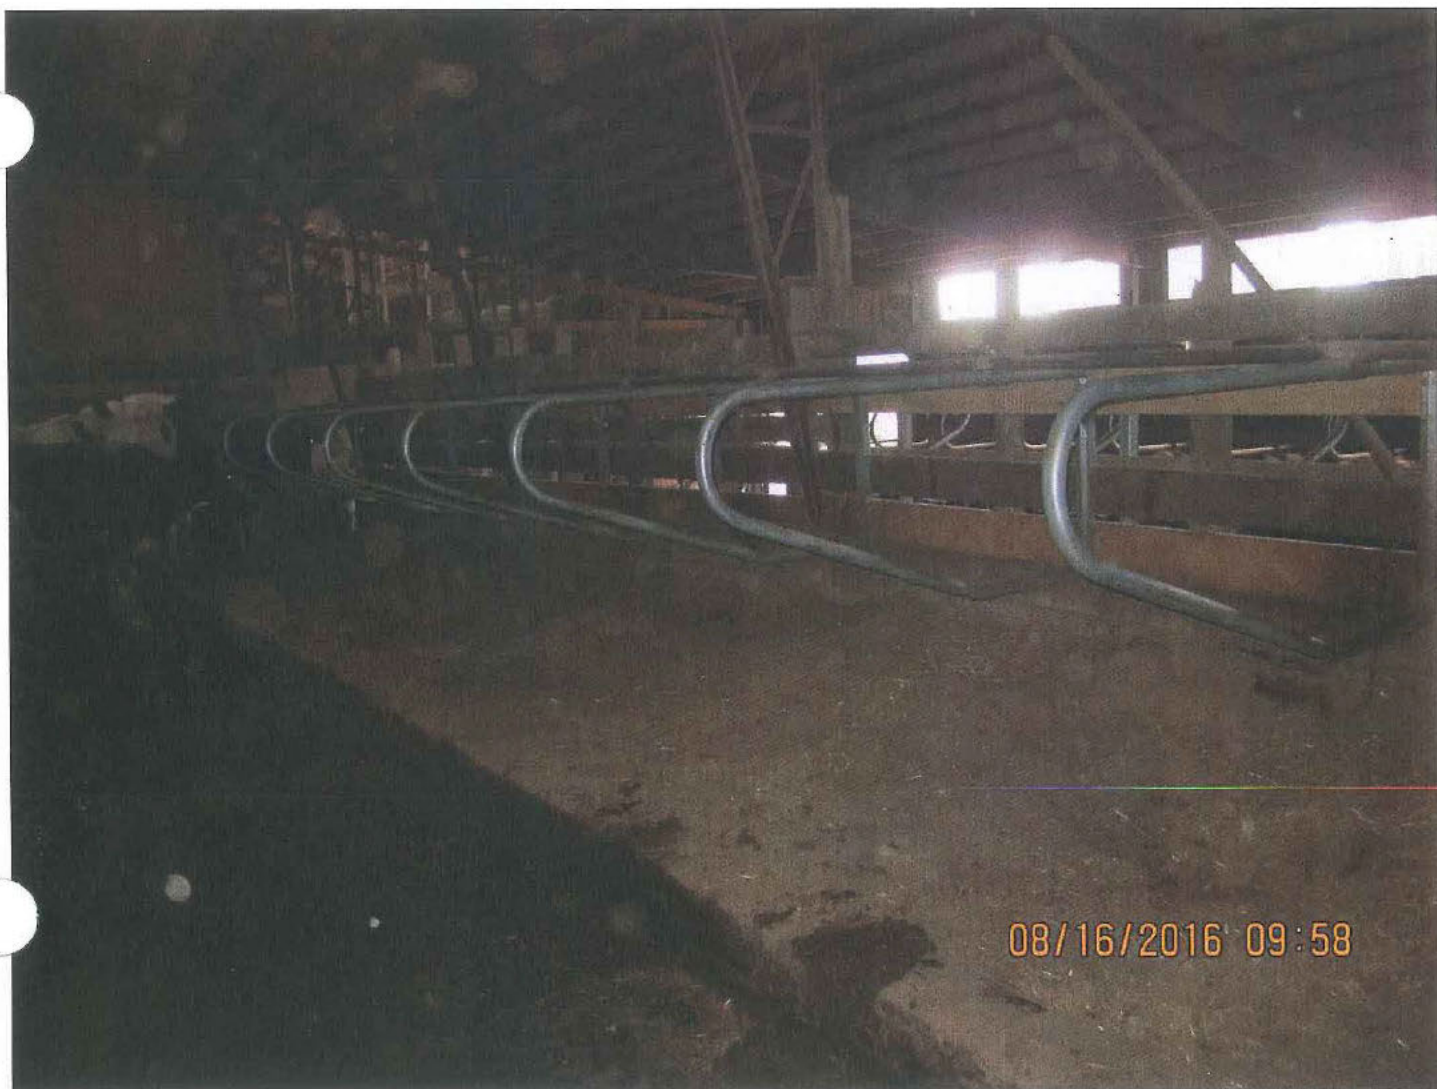
Photograph No. 5 (file IMG_0714)

Description: Sand bedding in Freestall Barn. Cow lanes within Freestall Barn are scraped with a skid steer to remove manure and dump it into the concrete Manure Storage Vault.

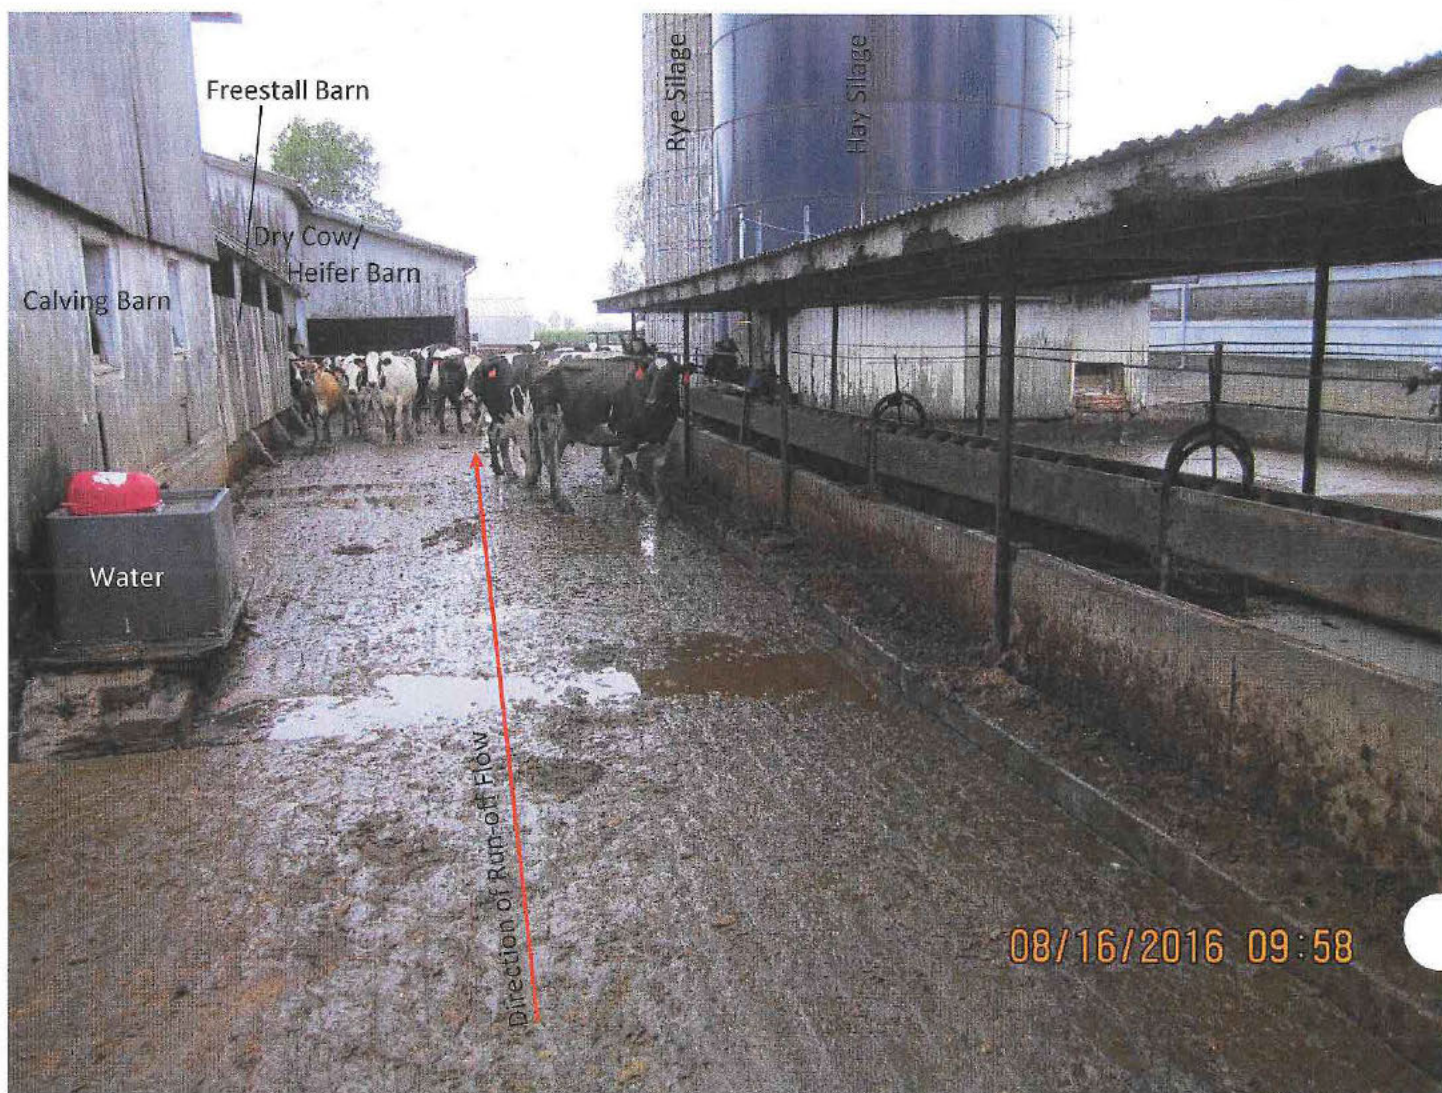
Photograph No. 6 (file IMG_0715)

Description: Concrete corral area on east side of the Calving Barn and Freestall Barn. Storm water run-off flows north to the constructed drainage trench.

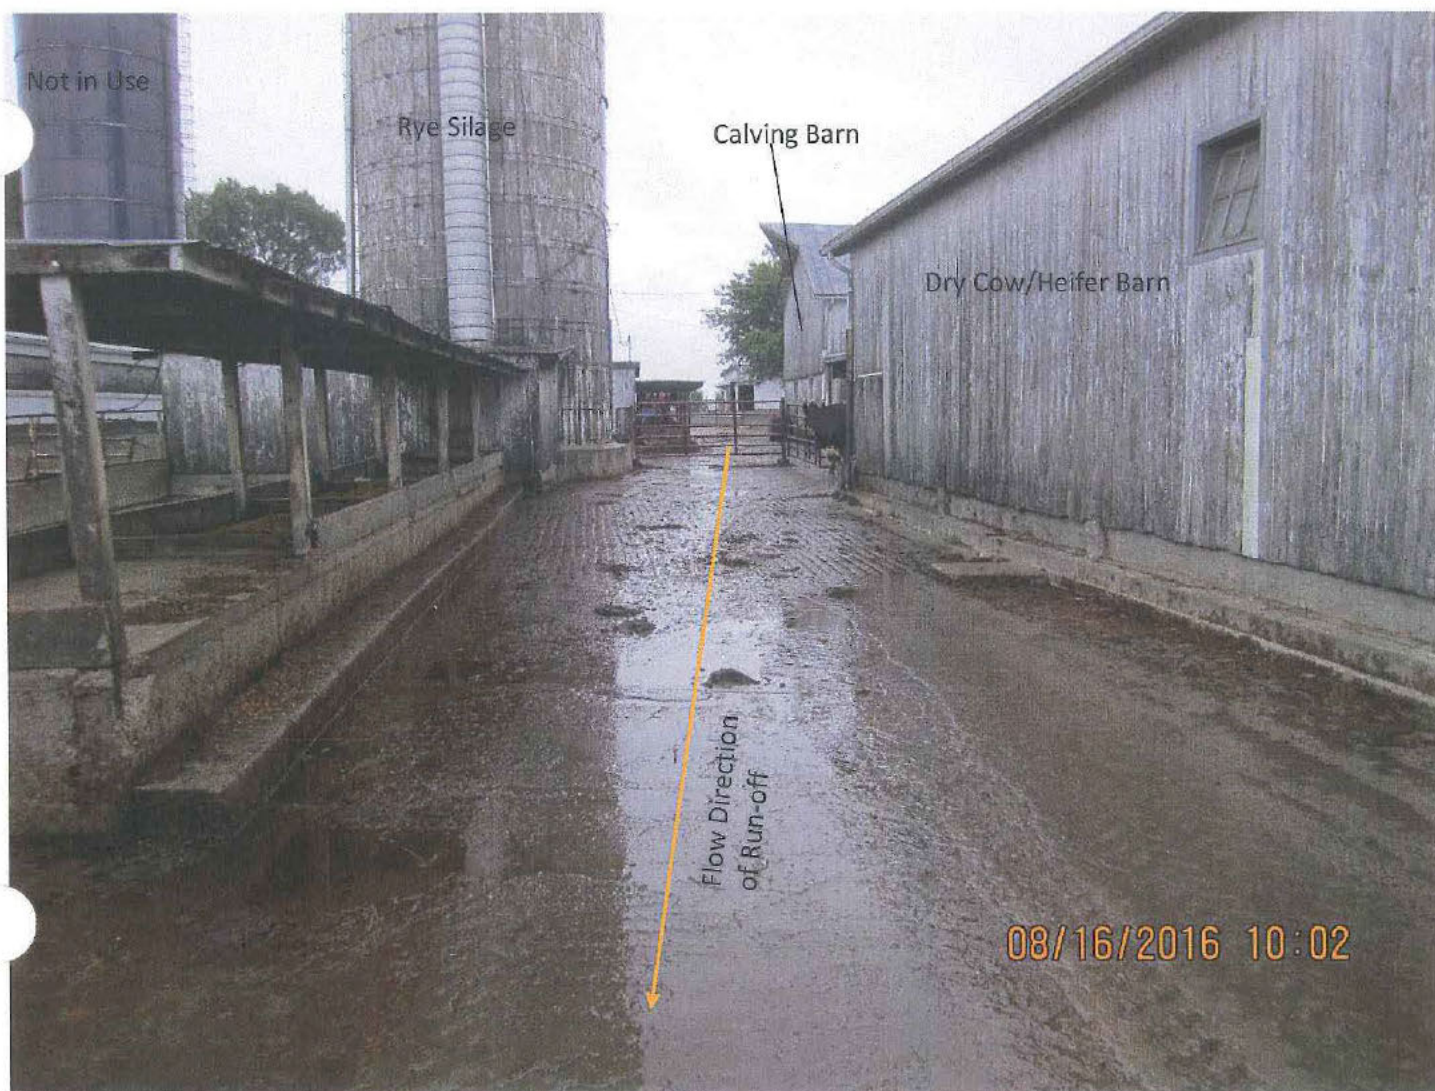
Photograph No. 7 (file IMG_0716)

Description: Concrete corral area on east side of the Dry Cow/Heifer Barn. Storm water run-off flows north/northeast to the constructed drainage trench.

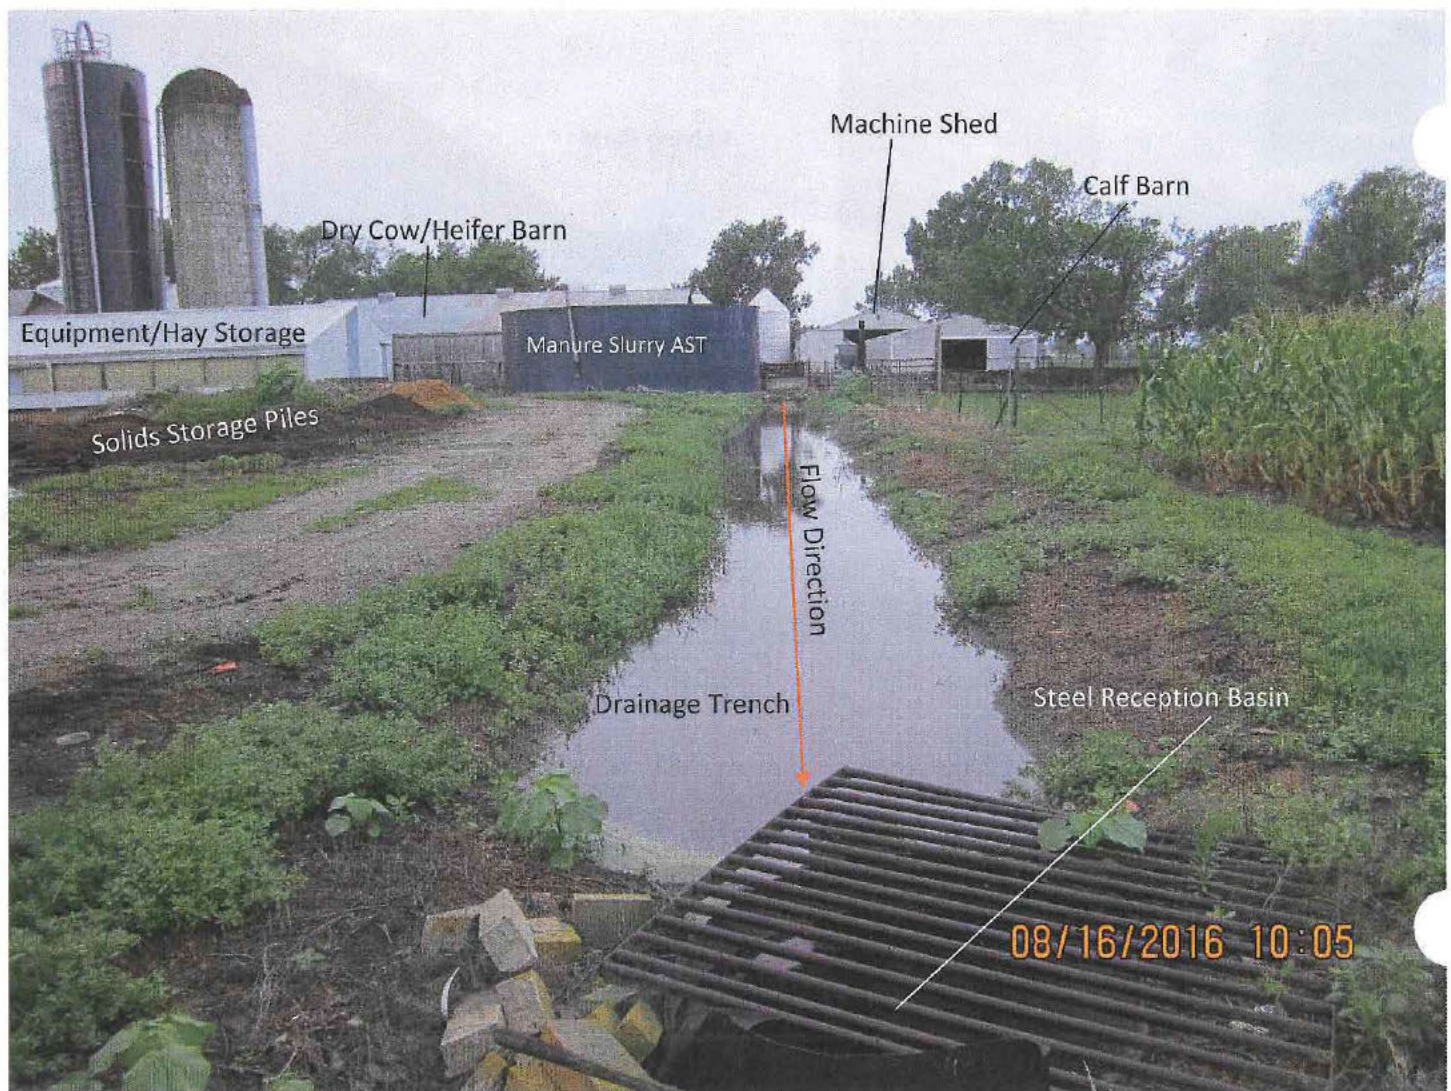
Photograph No. 8 (file IMG_0717)

vault (Attachment 2, Photograph 13) and into the manure slurry aboveground storage tank (manure slurry AST) by dairy staff as needed (Attachment 2, Photographs 8 and 13).

At the time of the inspection, I observed contaminated storm water run-off from the concrete corral areas on the east side of the animal barns at the dairy flowing into the drainage trench within the production area. The run-off was flowing through the drainage trench and into a steel reception basin. According to [Ex. 6. (Personal Privacy)] that basin is constructed with an outlet pipe that directs flow to the northeast, eventually discharging into an unnamed intermittent tributary to Mess Ditch. During the inspection there were periods of light, steady rainfall. According to www.weather.com, the New Bavaria area received a daily total rainfall of 0.21 inches on August 16, 2016 and 0.19 inches on the previous day of August 15. Paul Novak and I collected 1 sample set "S01" from the drainage trench flow as it entered the steel reception basin (Attachment 2, Photograph 20). We provided a split sample of S01 (with a signed chain of custody) to [Ex. 6. (Personal Privacy)] along with a printed summary of the analyses to be performed on the samples we were sending to the laboratories. The sample was collected under the *General Field Sampling Plan for AFO Inspections FY 2016* for the OECA Cleveland Office.

Description: Contaminated storm water run-off flows from the concrete corral areas into the drainage trench which flows east into a steel reception basin.

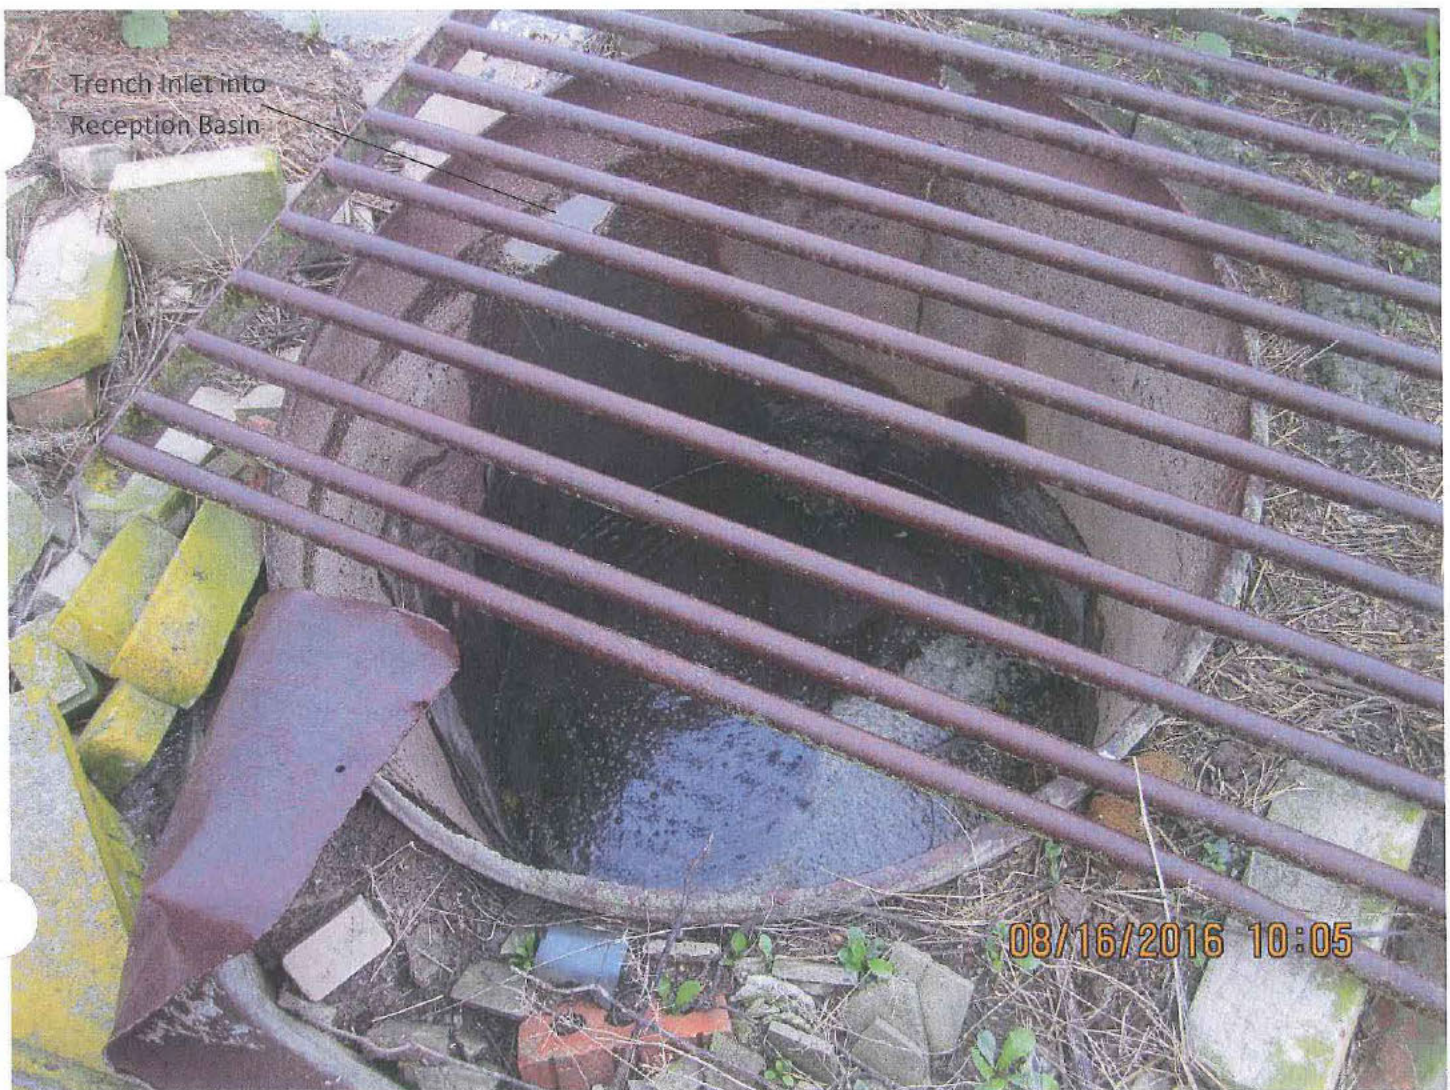
Photograph No. 9 (file IMG_0718)

Description: View into the steel reception basin at the east end of the constructed drainage trench. There is a small diameter hole cut into the steel wall of the basin to allow drainage to flow into the basin.

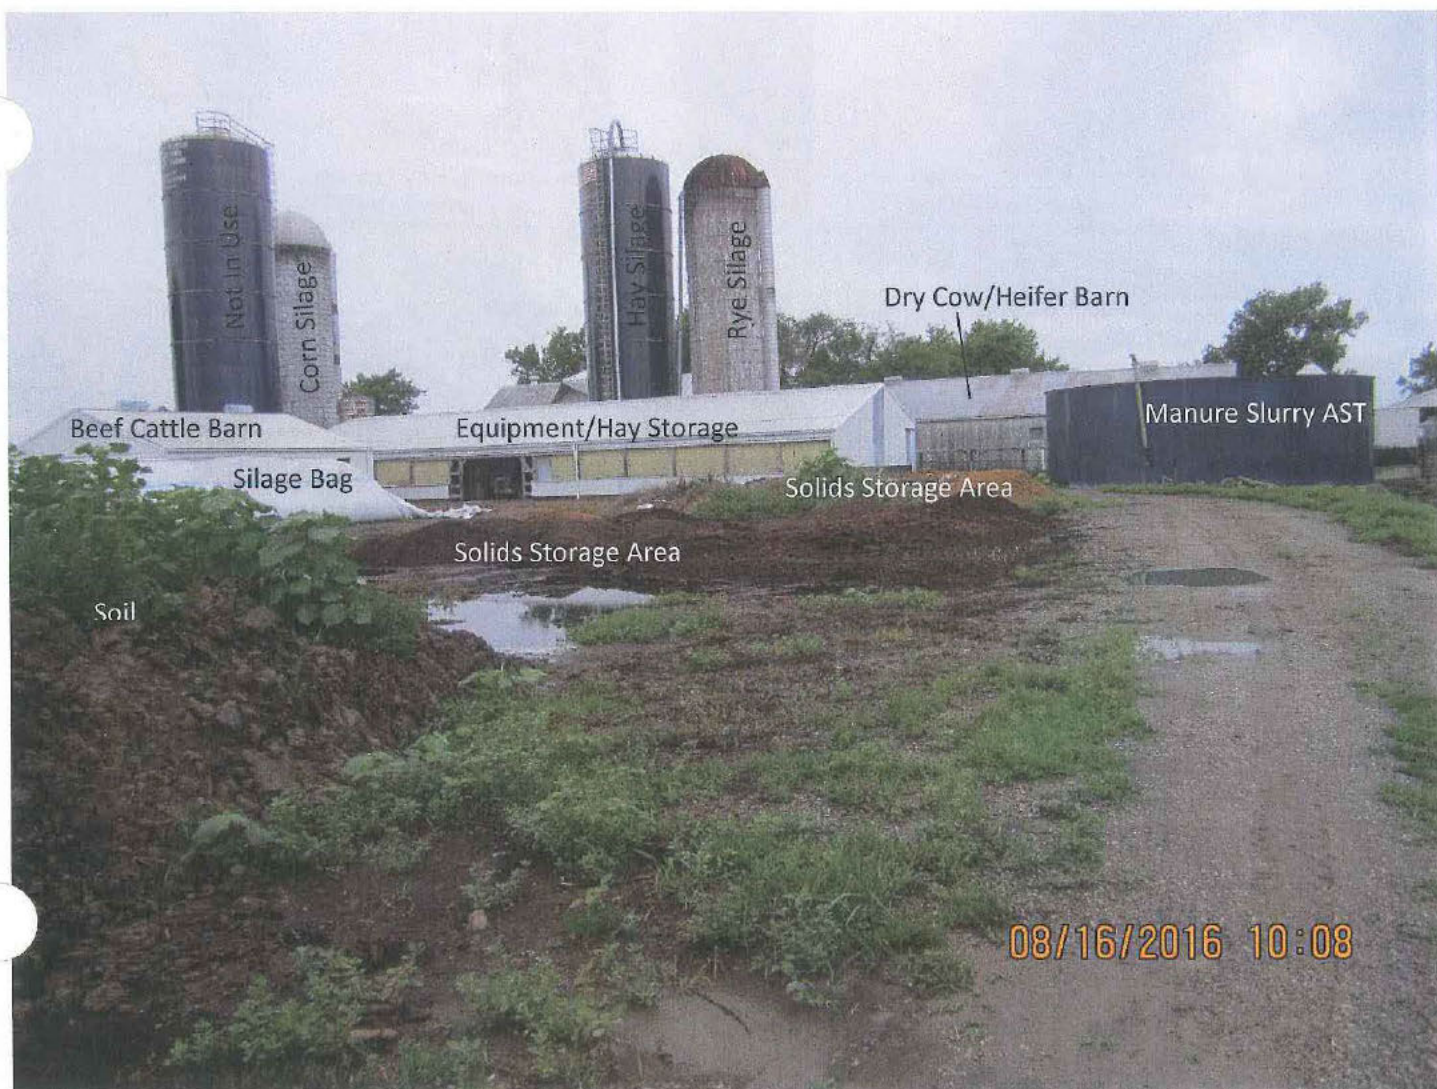
Photograph No. 11 (file IMG_0720)

Description: View of the Solids Storage Area where silage bags are stored along with manure solids piles and waste feed piles. Storm water run-off in this area can pool in depressed areas or drain north into the constructed drainage trench.

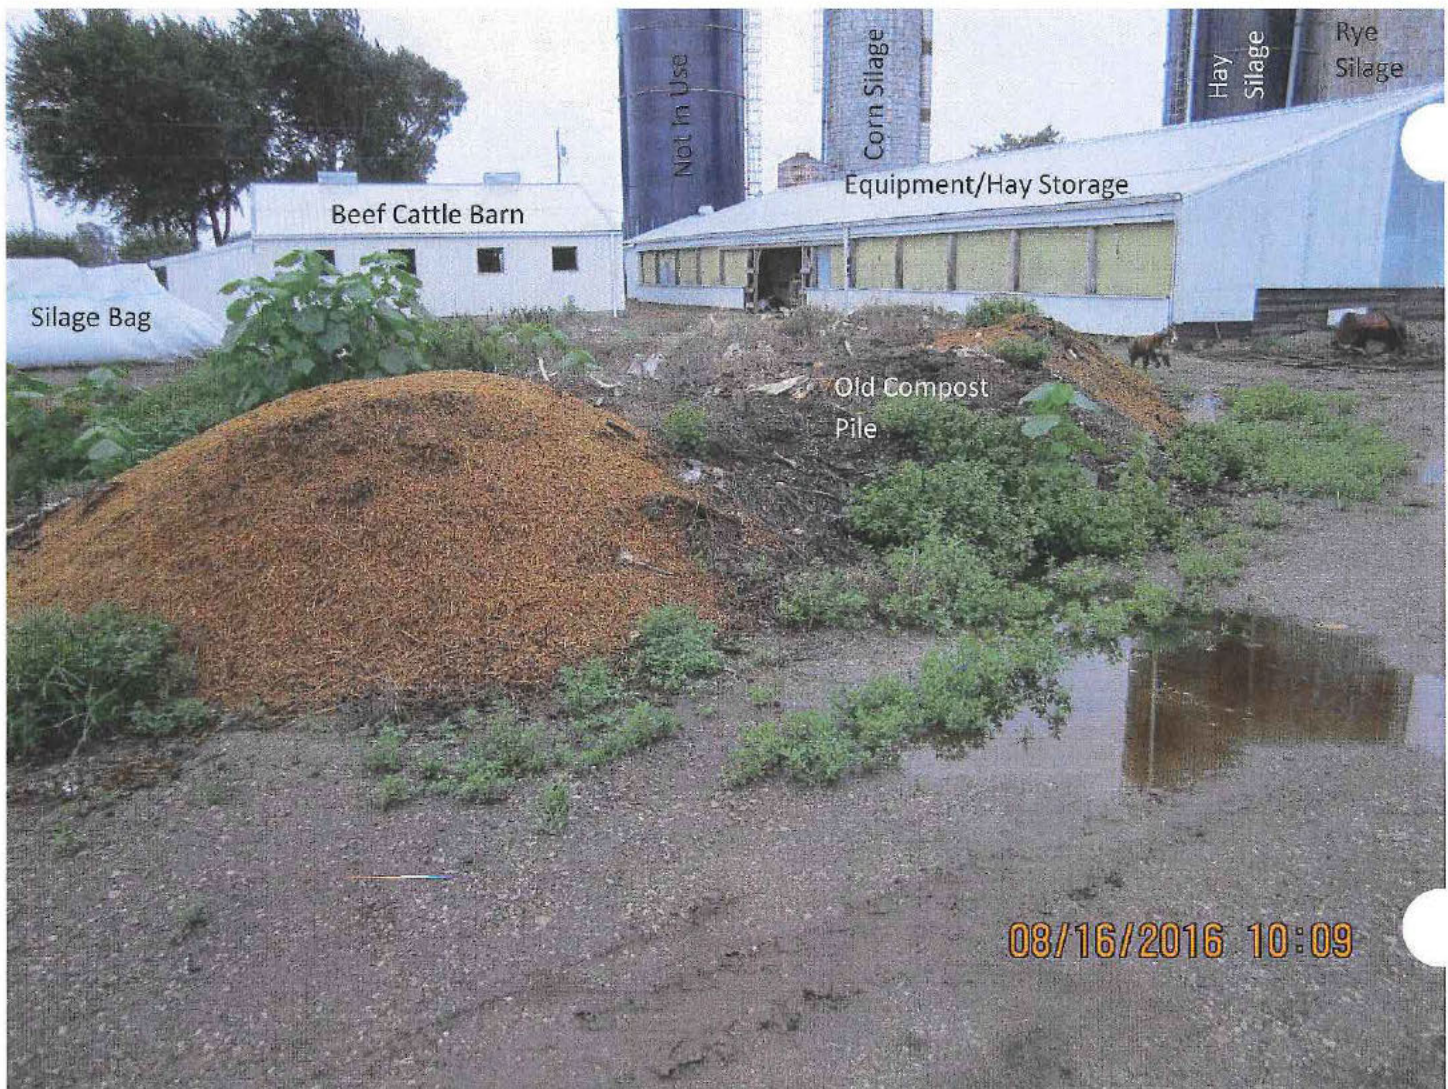
Photograph No. 12 (file IMG_0721)

Description: View of the piles of waste feed, manure solids and an old compost pile stacked at the north end of the Solids Storage Area. Storm water run-off and leachate would drain east across the gravel driveway into the drainage trench.

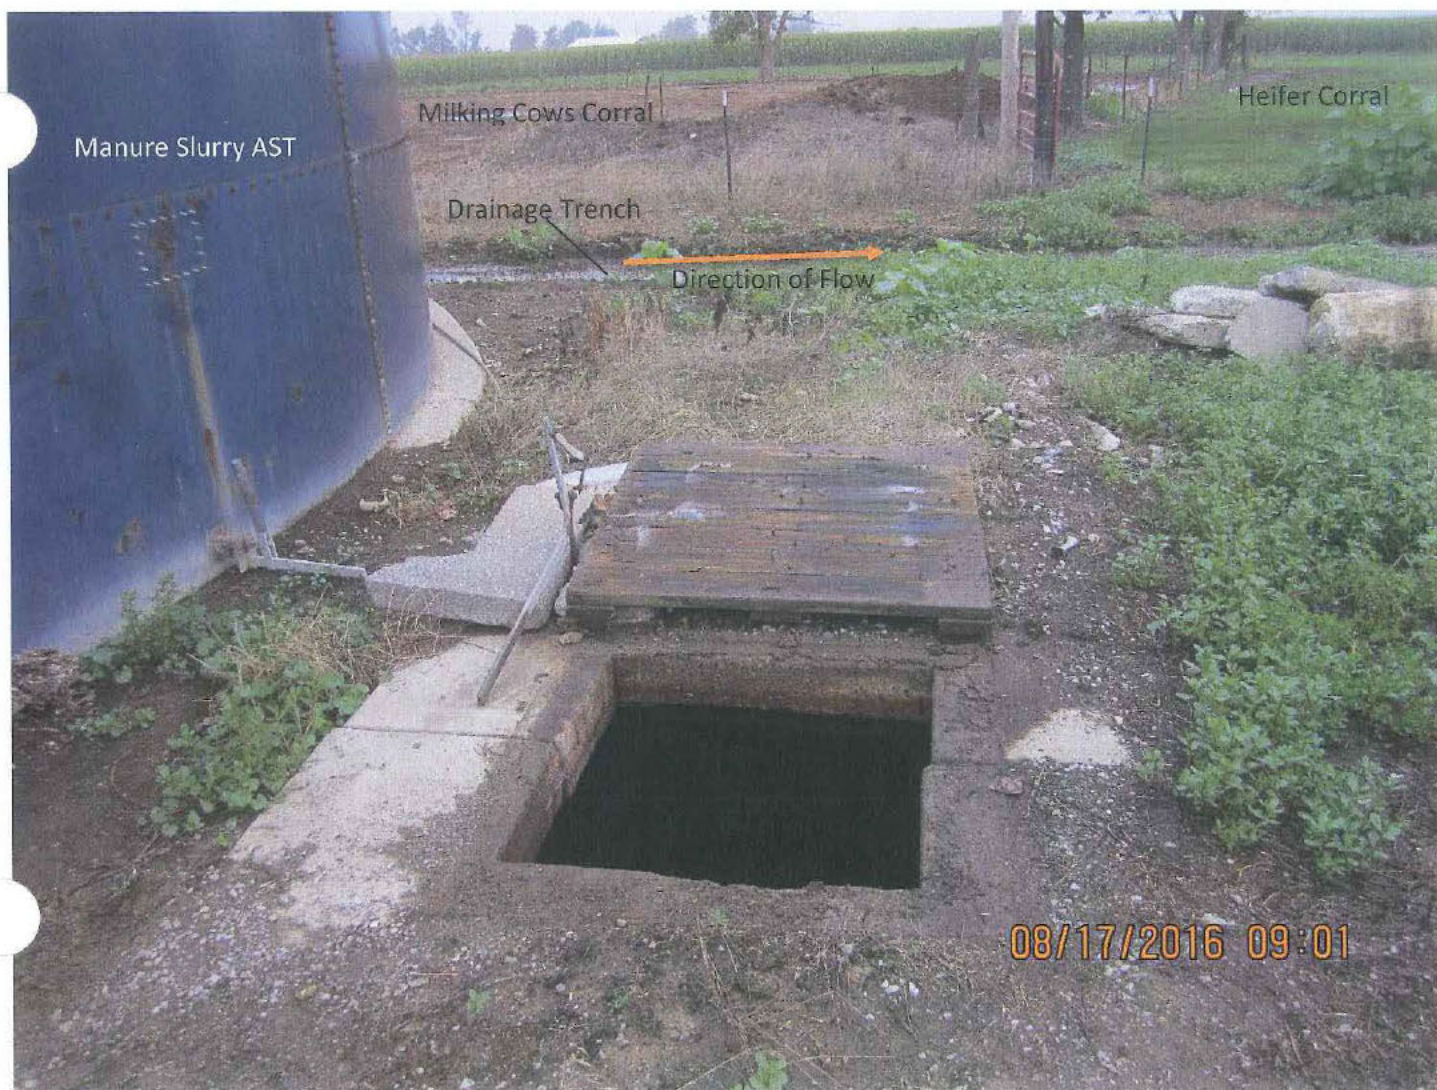
Photograph No. 13 (file IMG_0742)

Description: Access hole into north end of concrete Manure Storage Vault that is adjacent to the Manure Slurry AST. There is a wooden cover that is used to cover the opening. This is the opening used to access the vault in order to pump manure liquids from the vault into the Manure Slurry AST. The vault is located on the east edge of the Manure Slurry AST.

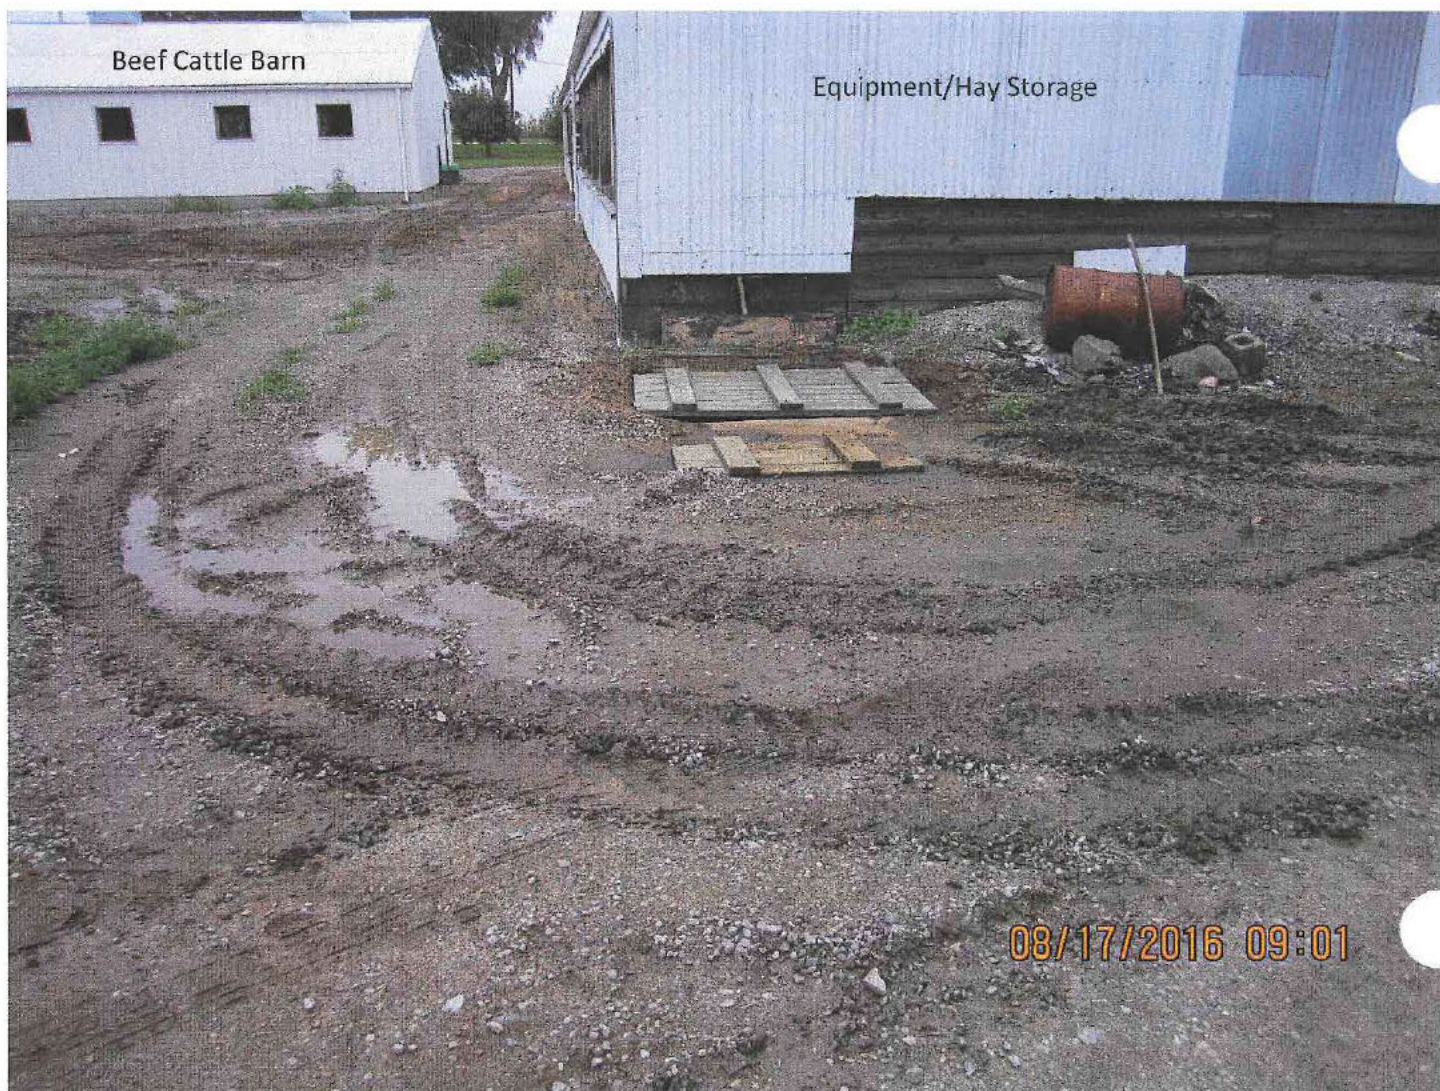
Photograph No. 14 (file IMG_0743)

Description: Access holes into the south end of the concrete Manure Storage Vault. Wooden covers sit over the access-ways until access is needed to dump scraped manure into the vault.
